# TROUBLESHOOTING YOUR RIFLE and SHOTGUN

By J. B. Wood

**Do-it-Yourself  
Diagnosis and Repair  
for Rifles and Shotguns**

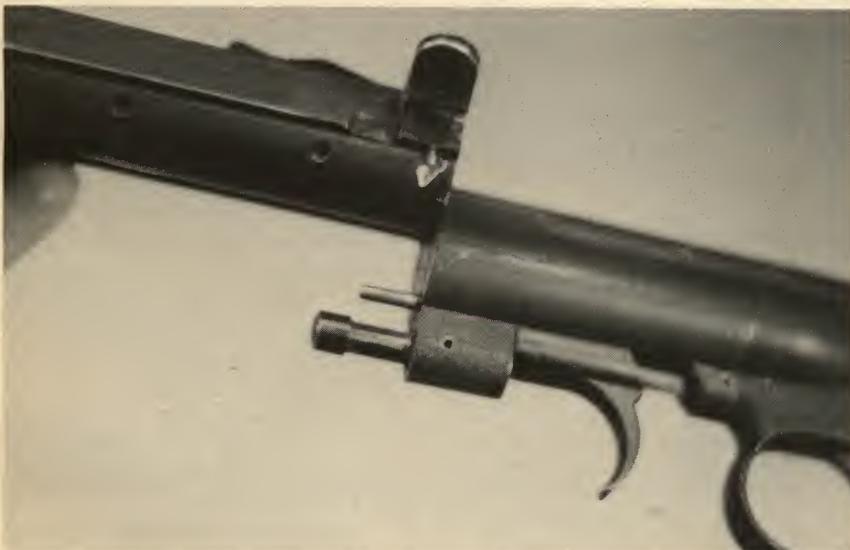
With the barrel pivoted to loading position, the barrel latch plunger and stud can be seen. Note also the end of the repair pin, just below the pivot-handle.

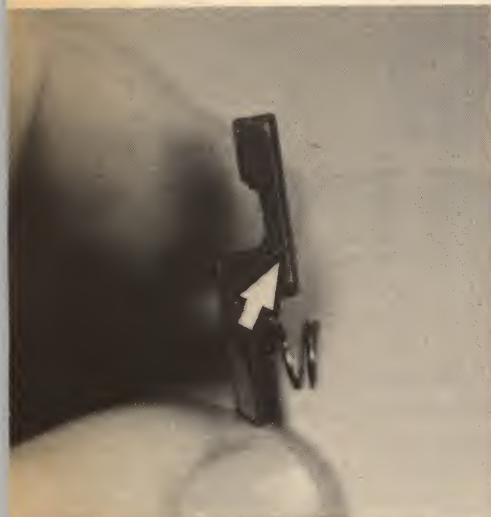
This is the cartridge stop. Its upper arm (arrow) is cammed outward by an incline on the barrel extension, and there is often wear at the contact point. This can usually be repaired without replacement.

The forward edge of the carrier latch acts as a primary shell stop, and the secondary shell stop is a separate part, operated by its upper arm contacting an inclined surface on the barrel extension. This contact point will occasionally wear to such an extent that feeding will be affected. The shell stop can be replaced, of course, as all parts are readily available, but this is usually not necessary. The upper arm of the shell stop can be heated and reshaped slightly inward, to restore the proper reach.

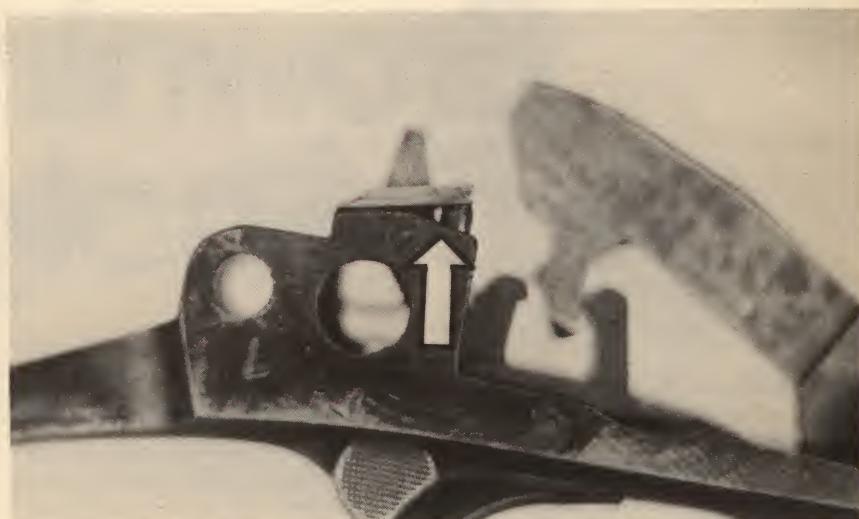
Arrow indicates the safety sear, a part that usually causes trouble only during amateur reassembly.

The internal mechanism includes a safety sear, a device that prevents movement of the trigger until the breech is fully closed. This part causes no trouble in the normal operation, but it is the nemesis of the amateur reassembler. Unless he knows that the upper arm of the safety sear must be tipped into its track inside the bolt link bar, he'll never get the trigger housing back into place in the receiver. I have observed one case in which the safety sear pin was broken because someone lost patience and used force.

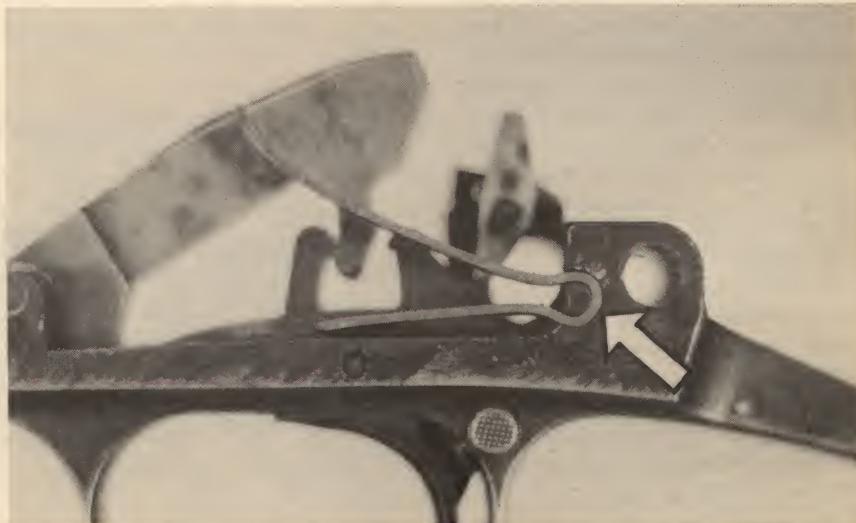
A blade-type carrier spring (arrow) is keyed into the trigger housing. These do not break often, but are susceptible to weakening.

The carrier spring is a flat type, V-shaped, with a keyhole-bend designed to fit over a stud in the receiver on the older guns, and into a recess in the trigger housing on later pieces. The carrier itself is also different on early and late models, being a single part on the older guns, and a two-part assembly on late ones. The spring occasionally breaks, but more often, on very old guns, it loses some of its tension, failing to return the carrier with sufficient snap for rapid feeding. Replacement of this spring is extremely simple.

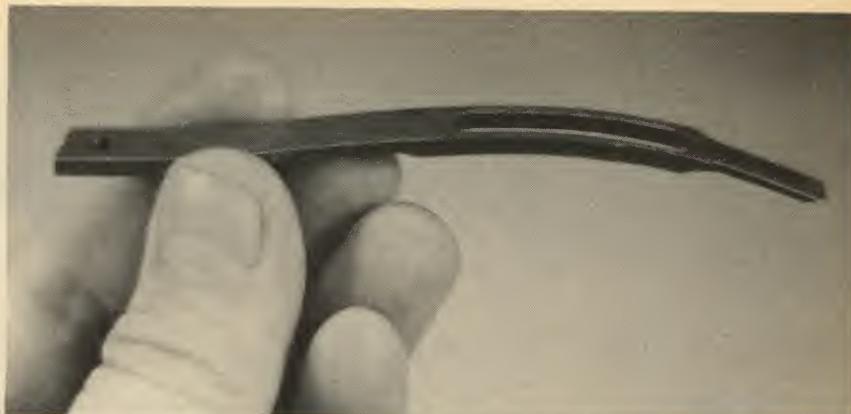
The hammer spring seldom breaks, and if it should, almost any gun shop will have a replacement. This is fortunate on both counts, as this is a heavy blade-type spring with an open-

A typical A-5 spring is a heavy blade-type, with an opening in its forward position for the upper arms of the trigger. Reproduction would be difficult.

ing in its forward portion for the upper arms of the trigger, and reproduction would be difficult. The installation of a replacement should be done by a gunsmith. These same remarks could also apply to the combination trigger and safety spring, though this one could be made a bit more easily.

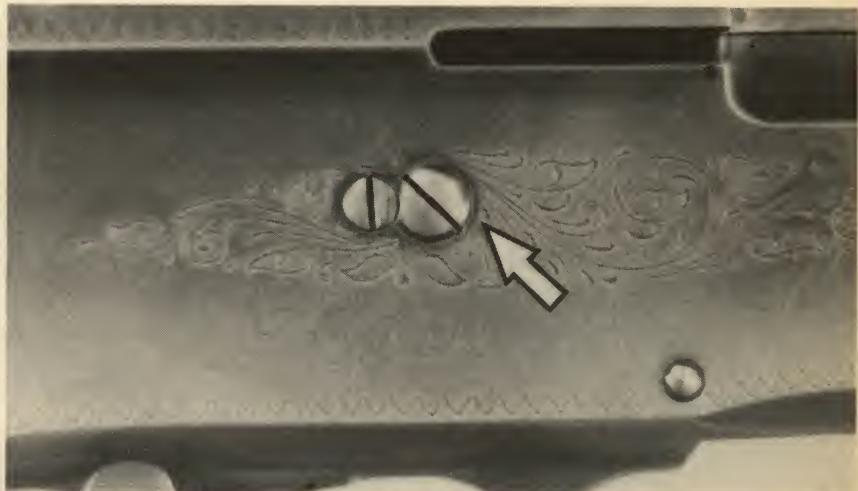
The carrier pivots on the blank tips of two screws which enter the receiver on each side, and it should be noted that these are individually fitted, especially on the older guns, and should

not be switched during complete disassembly and reassembly. In some cases, changing these from one side to the other will cause binding of the carrier which in turn may cause a failure to feed.

The arrow points to the right carrier pivot screw, which has a counterpart on the other side of the receiver. These are usually fitted exactly to each side, and if taken out, they should not be switched.

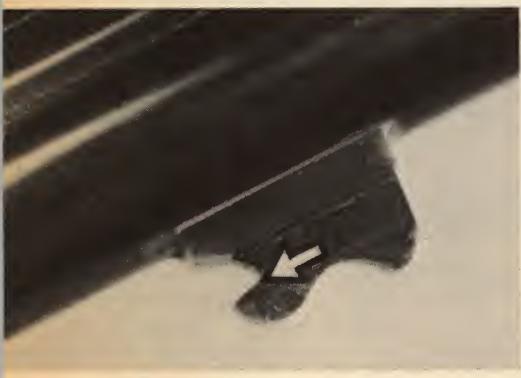
One of the differences is in the take-down procedure. On the Citori, the forend must be removed before the barrels can be separated from the receiver. The forend is retained by a lifter-type latch, and there is a beaked lug on the lower barrel which mates with the hook of the latch. After many takedowns, over a number of years, the beak on the lug will eventually sustain some wear. When this occurs, and the forend loosens, any tightening operation should be done to the latch in the forend, not the lug on the barrel.

The forend is retained by a lifter-latch, and wear may eventually occur on the beak of the latch lug on the lower barrel at the point indicated by the arrow.

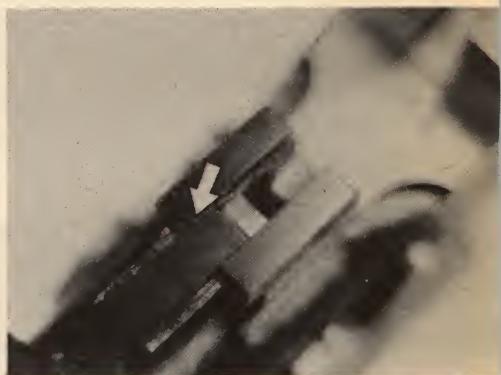
When replacing the forend on the assembled gun, the small pivoted part at the rear of the forend (the cocking lever lifter) must be carefully inserted into its T-slot between the front underlugs of the barrel unit before swinging the forend up into place.

During replacement of the forend assembly, the cocking lever lifter (arrow) must be carefully reinserted into its T-slot between the front underlugs of the barrel unit.

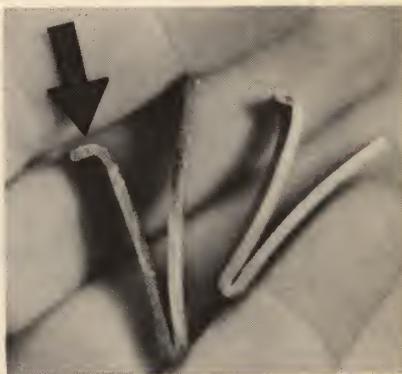
Occasionally, the right-angled tip of the hammer springs will snap off, at the point indicated by the arrow. Note that the two springs are not of equal size, and are not interchangeable.

which contacts a groove in the hammer, and this tip is prone to breakage. This type of spring will also weaken if the gun is left cocked for long periods of time. Commercially-made general replacements for these springs are available, but they require some fitting; and, installation is definitely a job for your gunsmith (and not an easy one!). When ordering a replacement for one of these springs, it should be noted that they are not of equal size and are not interchangeable, so you must specify which of the two is needed.

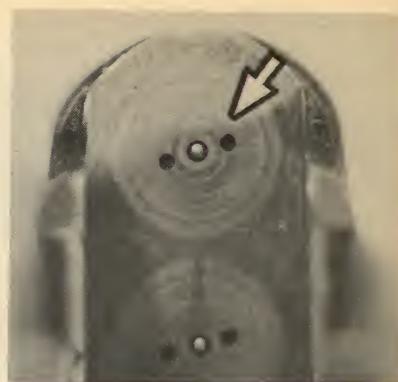
For firing pin removal, the bushing (arrow) must be unscrewed, using a special wrench.

At some point in time, you will be faced with a broken firing pin—it can happen, eventually, to even the finest gun. In the Daly these are retained by bushings that are removable from the front of the breech face. Removal requires the use of a special two-pronged spanner; and, these bushings should never be removed by makeshift means, because it will usually result in damage to the bushing or breech face. If a gunsmith does not have the specific wrench to fit the Daly bushing, an excellent and relatively inexpensive wrench is available from Dan Bechtel's B-Square Company. If original replacement firing pins are not available, they are of simple design, and are not difficult to make.

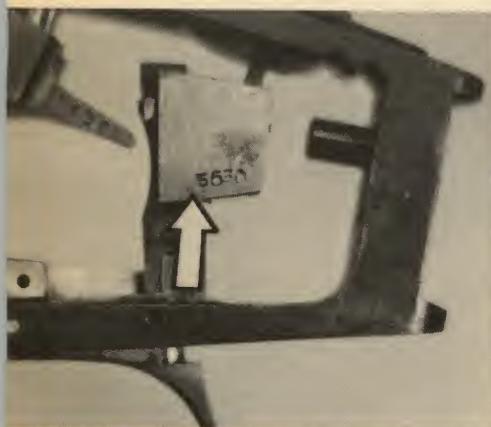
The safety catch is also the barrel selector, being moved from side to side to expose a small "U" and "O" on the upper tang—it controls which barrel is fired first. After the first shot, an internal inertia block, operated by recoil, automatically switches the trigger contact to the sear for the other barrel. The inertia system is balanced by the weight of the block and the tension of its spring, and normally requires no adjustment. If repair or adjustment is ever required, a com-

Here, the arrow points to the inertia block which switches trigger contact to the other sear after the first shot is fired.

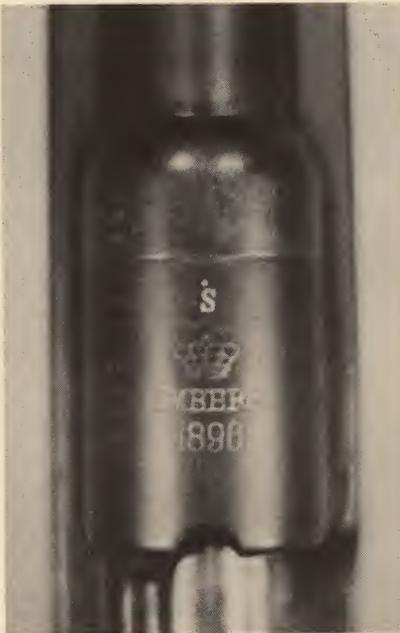
Receiver ring marking shows that this gun was made at Amberg Arsenal in 1896. Note the "S" above the crown, indicating that this gun was later altered to use the redesigned 8mm cartridge of 1905. In spite of the marking, these guns are only marginally safe with modern 8mm rounds.

you might need. Several of the surplus dealers are still selling some of these guns, and are advertising them as safe with present-day 8mm Mauser rounds, basing this on the "S" marking. Once again, shooting even the relatively mild U.S. commercial load in the Model 88 is risky. Feeding one of these a warmed-up 8mm handload could create some interesting problems for your hospital.

If you want to safely shoot the Model 88, there are two ways: Either obtain the proper dies and carefully handload your cartridges down to the early pressure level, or have one of the custom loaders, such as Ballistek, make them for you. Otherwise, the Model 88 should be used as a conversation piece on the wall of your den.

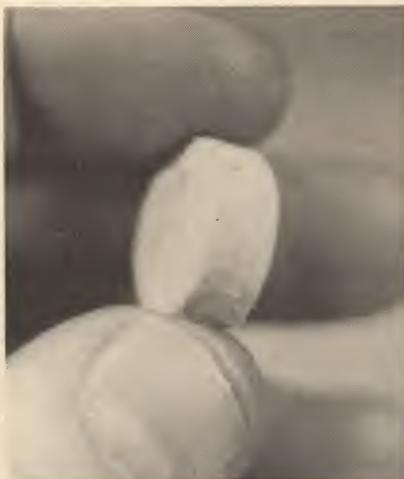
When the fiber buffer at the rear of the receiver deteriorates, it can be replaced with a 16-gauge shotshell wad. It's a perfect fit.

no chronic problems, but I have repaired them on occasion. I have noticed that the ones which required repair had seen long and hard use. At the rear of the receiver, inside, on the forward face of the receiver end piece, there is a fiber buffer which cushions the impact of the bolt as it is blown open. After several thousand rounds, the repeated compression will cause the fiber to break down, and replacement of the buffer will be necessary. As recently as a year ago, replacement parts for the 755 and 760 were still available from H&R, but few of the smaller gun shops carry parts for these short-production guns in stock. If the parts are not readily obtainable locally, there is a quick and easy way to replace the fiber buffer—a 16-gauge shotshell wad is a perfect fit inside the receiver. The wad will need to be holed at the center for the short rod on the receiver end piece, and its thickness may have to be adjusted slightly for the proper rear position of the bolt, but this is a job that even the amateur can do easily.

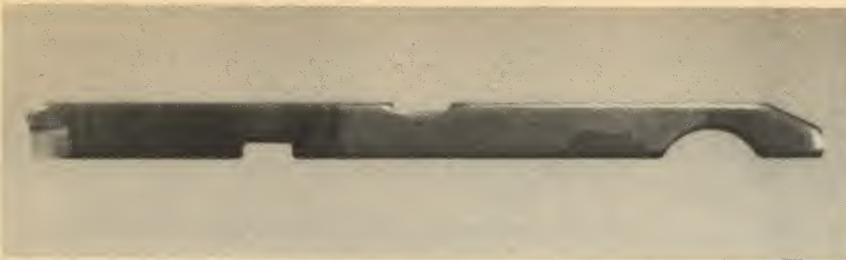
The firing pin of the Model 760 is made of flat steel stock and is not difficult to reproduce.

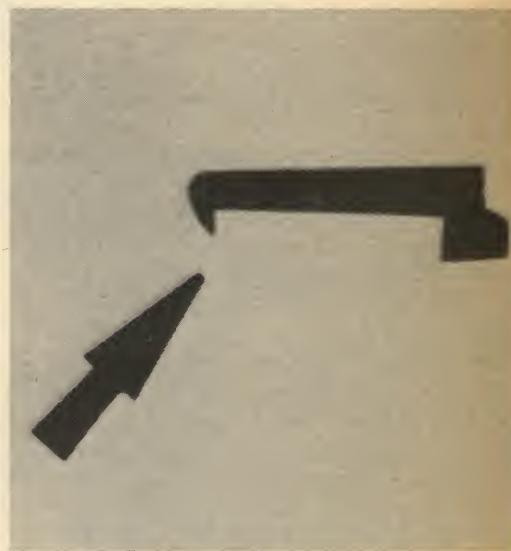
The extractor has a fairly thin beak, but is not under the severe impact stress that is usually the case with a semi-auto, as the closing of the bolt is done by hand. I have replaced exactly two of these over the years; so, in spite of the thin beak, these must be quite durable. Here, again, if no new parts are at hand, making replacements will

The extractor has a fairly thin beak (arrow), and occasionally breaks at that point.

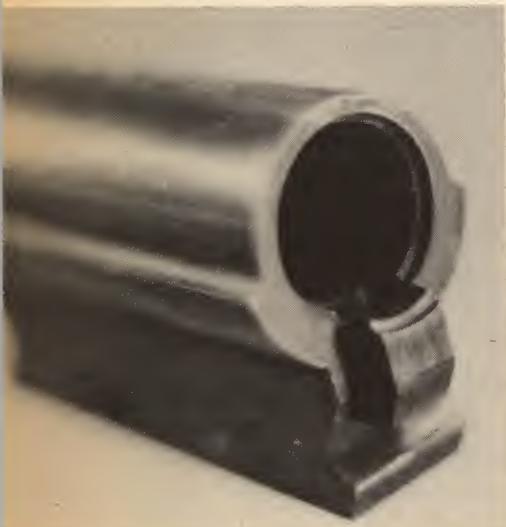
The Topper's ejector is a heavy, well-designed part—it rarely gives any trouble.

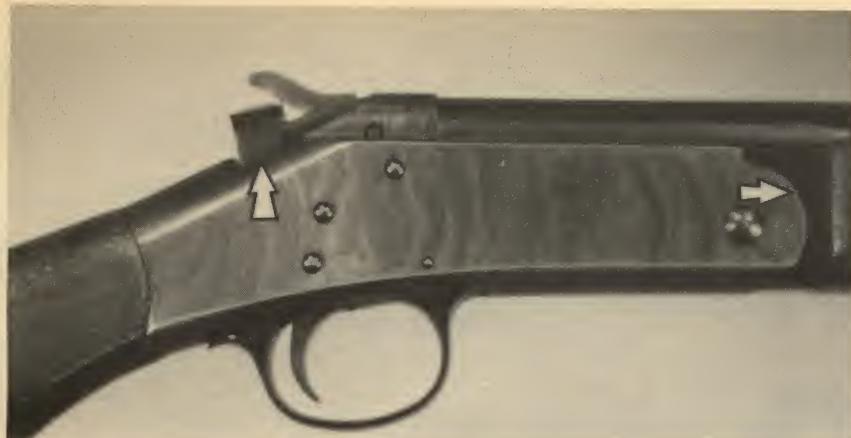
On late guns, the trigger guard and the spacer piece between the forend and the receiver are of plastic. The latter part is under no extreme stress, and the use of plastic material in this location causes no problem. The trigger guard, however, is subject to impact every so often, in normal use, and these do occasionally fracture. Replacement guards are not expensive, and all parts for the later guns are readily available. For the very early guns, some parts may have to be obtained from the used-parts dealers.

Left arrow points to the vertical barrel latch found on later models. The right arrow indicates the plastic fore-end base.

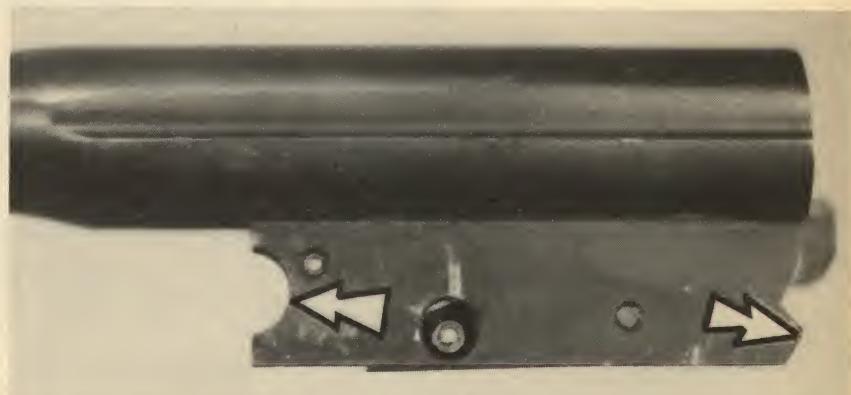
When extreme wear occurs in the locking-lug area, it can be remedied by installing a slack pin at the center of the pivot recess (left arrow), and by peening at the center of the locking lug (right arrow), just below the lip.

When a gun has seen long, hard use, and the barrel locking system has become loose, it can be repaired in the same manner as on most other single and double barrel guns. End play can be taken up by the installation of a steel pin at the center of the pivot recess on the underlug of the barrel. Vertical looseness can be corrected by peening the locking lug at its center, just below the lip, to raise the locking surface. It should be stressed that the impact point should be below the edge of the lug, as peening the edge itself

will do no good at all—the first shot afterwards will flatten it again.

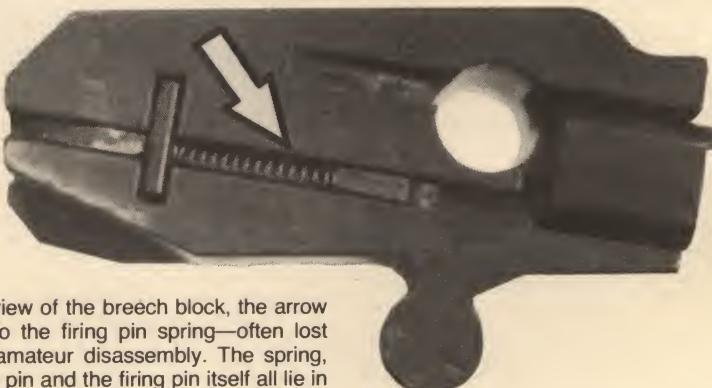
In this view of the breech block, the arrow points to the firing pin spring—often lost during amateur disassembly. The spring, its base pin and the firing pin itself all lie in recesses in the side of the breech block, retained only by the inside of the receiver.

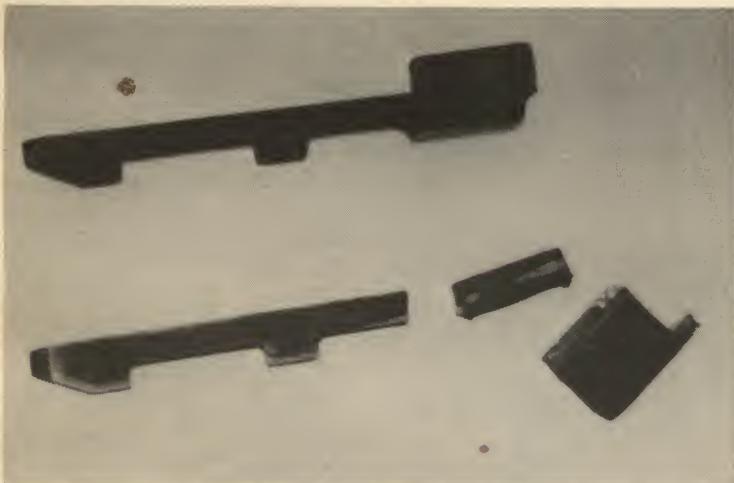
Two of the weakest points in the design are the firing pin and the ejector system. In order to bypass the large pivot pin, the firing pin has a centrally positioned head which is offset to go down the left side of the breech block. Since the applied force from the hammer blow is not in a straight line, the offset portion of the

firing pin is under heavy strain each time it is struck, and breakage is not unusual. Fortunately, replacements are readily available at most gunsmiths and from Ithaca. I once altered a Model 49 to use a straight, round-section firing pin which passed through the pivot, but considering the amount of work involved and the value of the gun, this is not really a feasible alteration.

Because of its design, the firing pin breaks with some frequency. In this picture the firing pin on top is intact, while the one on the bottom is broken in two places.

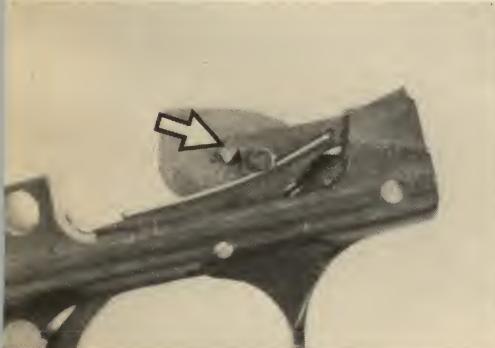
In older guns, there may be some wear at the engagement (arrow) of the hammer stud and the rear beak of the slide stop.

age weakening. In older guns, there may be some wear at the engagement of the stud on the right side of the hammer with the rear beak of the slide stop. If the wear is light, the parts can be recut to restore the proper meeting. If this is not possible, the hammer, slide stop, or both can be replaced—all parts are readily available.

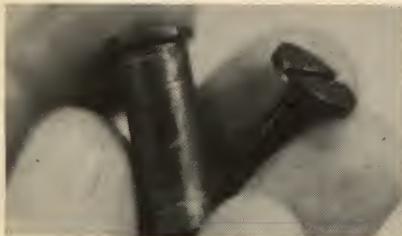
If the gun is taken down for transporting or storage, the barrel hinge pin and its retaining screw should be replaced in the receiver to prevent loss.

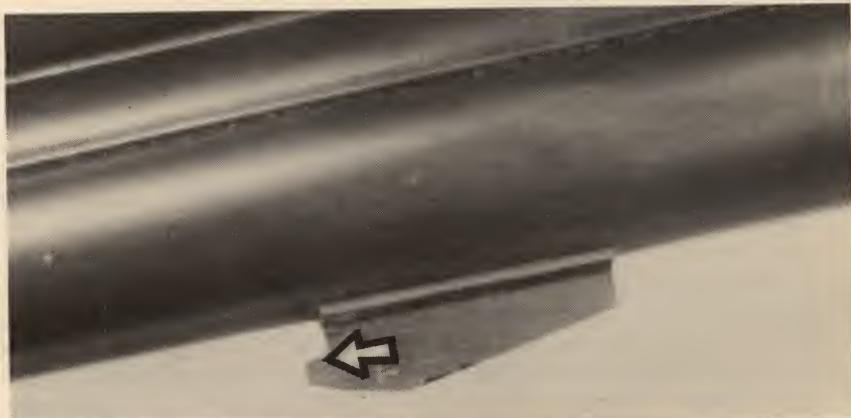
In fact, the only repair I have made on this gun, other than the routine replacement of an occasional broken firing pin, was one case in which the forend latch had become loose. The owner of the gun traveled to many Skeet and trap matches, and his gun was frequently taken down to be transported, causing wear in the forend latch system. The latch on this gun is the lifter type, with an inner beak on the lift-lever contacting a projection on the front of the lug mounted on the lower barrel. Since the heat of weld-

Looseness of the forend will be due to wear of the retaining lug on the lower barrel, at the point indicated by the arrow. Any repair should be done to the latch in the forend, not to the lug.

ing would loosen the entire lug, it is not possible to add steel to the front projection. Instead, the beak of the latch lever is heated and bent slightly, to tighten its engagement with the lug.

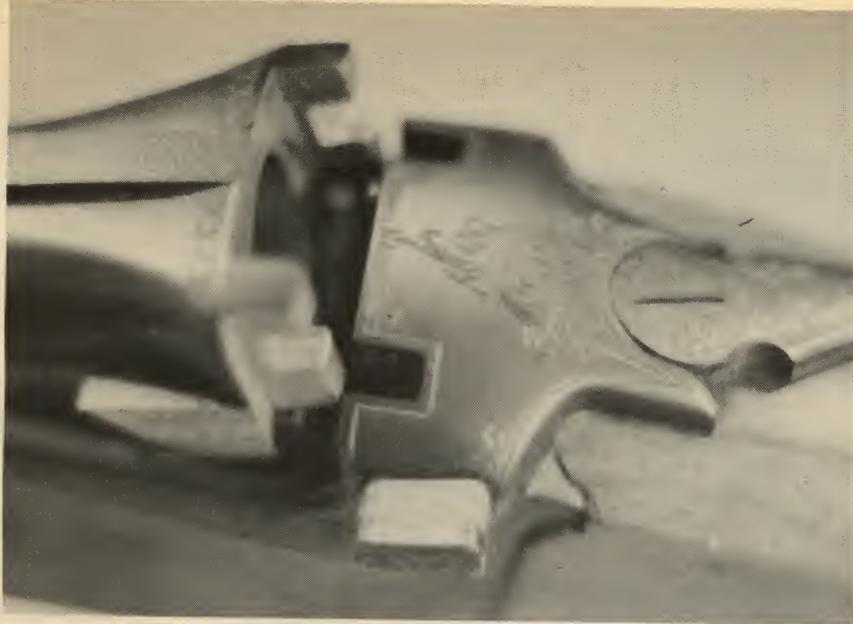
The Model 600 uses a variation of the Greener cross-bolt locking system, and any loosening will be after many years of hard use.

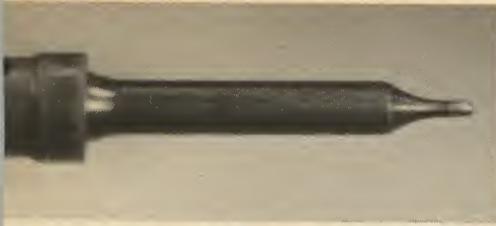
ences. The bolt design is extremely simplified and uses a unique tubular striker with an integral firing pin. The firing pin portion is well-shaped, strong, and it rarely breaks. If it should break, the pin can be repointed easily. Also, at the time of this writing, parts are still generally available from several of the dealers who specialize in surplus military items.

The firing pin portion of the long, tubular striker is well-shaped, strong and does not often break.

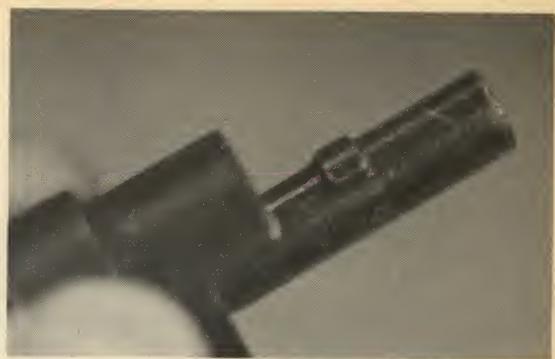
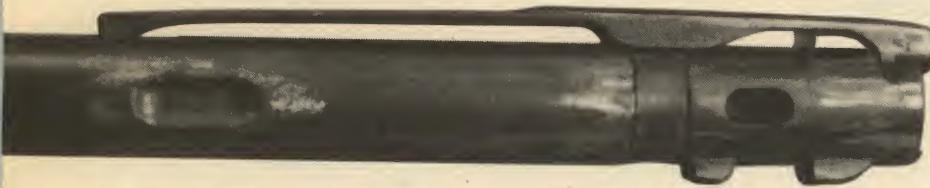
The long extractor is tempered to be its own spring, and is retained on the bolt by a Mauser-type ring. Note the large gas vent, and the small extra lug near the ring which operates the ejector.

tempered to be its own spring, and like most of those in this pattern it is more susceptible to weakening than breakage. A weak extractor tail can often be reshaped and retempered, but this is a job for the gunsmith. The combination safety catch and bolt end piece is retained on the bolt by internal recesses which mate with a large lug at the rear of the bolt, and no incidence of breakage has been seen. The inner shaft of the safety has a heavy lug which mates with an open track in the striker, a very secure safety system. The only times I have replaced the safety/end piece were in cases of loss. I can recall one incident in which an Arisaka owner was field-stripping his sporterized Type 99 on the shore of a lake, and during take-

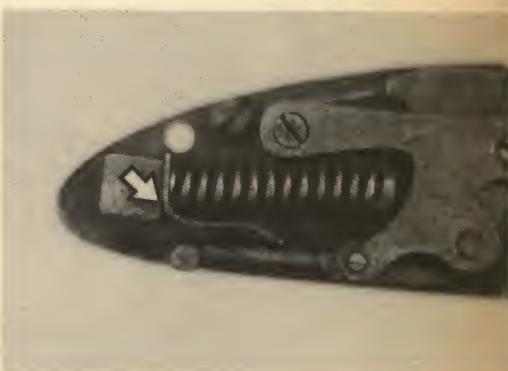
The hammers are powered by heavy helical coil springs, and these neither break nor weaken. The sear springs are flat, curved blades, and these do break somewhat more often. Replacements must be made and installed by a gunsmith, as parts for these old guns are not often available, and even when they are found, they are seldom interchangeable.

Hammer springs on the Knickerbocker are heavy helical coils and seldom break or weaken. The sears are powered by a curved flat spring (arrow), and these do occasionally break. Replacements must be made and installed by a gunsmith.

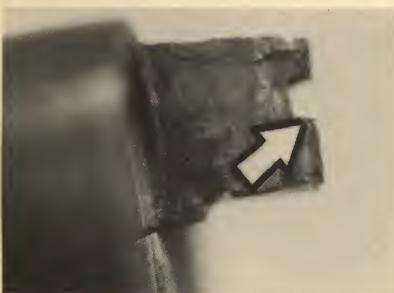
There is an auxiliary latching lug on the rear upper extension of the barrels, and this tends to wear at the point indicated by the arrow.

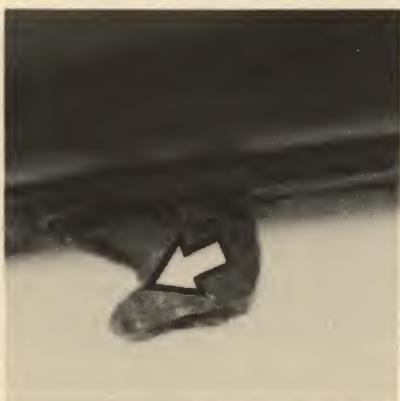
The forend latch lug below the barrels wears at the point indicated by the arrow and since heat cannot be safely applied to this area, tightening is best done by altering the beak of the latch lever in the forend.

The forend latch lug below the barrels is also subject to wear on the inside of its locking beak, and welding here is risky, as the heat can separate the barrels and ribs into four useless pieces. It is sometimes possible to lightly peen the beak toward the barrels, but there is a chance of breakage when this is tried. The best way to tighten a loose forend is to heat and reshape the beak of the lifter-latch, which can easily be removed from the forend for this operation.

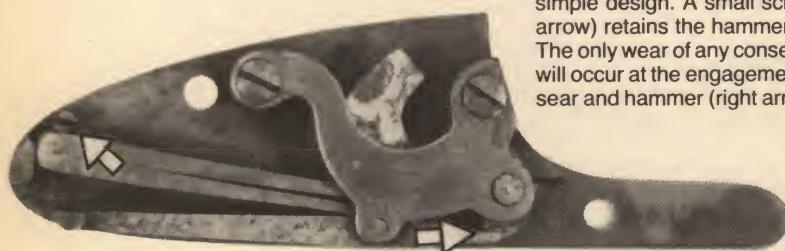
Other than the occasional breakage or weakening of one of the main-springs, the only point in the locks that may need attention is the engagement of the hammer and sear. If there is extreme wear or chipped edges in the sear beak or the the sear step on the hammer, the hammer may fail to stay cocked when the action is closed. In some cases, the hammer may jar off as the gun is snapped shut, and if that chamber is loaded, the situation will be called to your attention in a very positive manner. The contact points can be recut, or built up with weld, recut and rehardened, by any good gunsmith. This will cure the problem

The L.C. Smith sidelock is of very simple design. A small screw (left arrow) retains the hammer spring. The only wear of any consequence will occur at the engagement of the sear and hammer (right arrow).

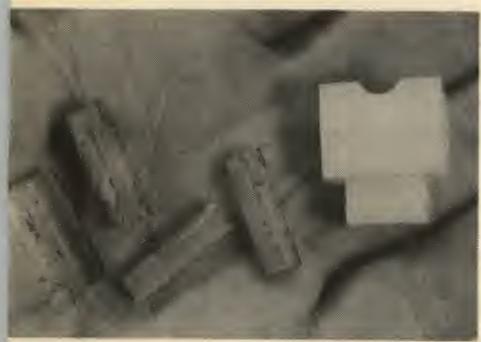
With long use, the nylon bolt buffer will eventually fracture, like the one shown at left. A new buffer is shown at the right.

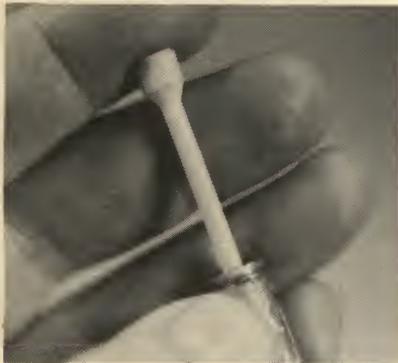
Made of plastic, the magazine follower seldom breaks in normal operation. It is easily damaged, though, when the magazine tube is out of the gun, since it protrudes about 1½ inches from the end of the tube.

While the magazine follower is made of plastic, it seldom breaks in normal operation; however, it can be easily damaged when the magazine tube is out of the gun.

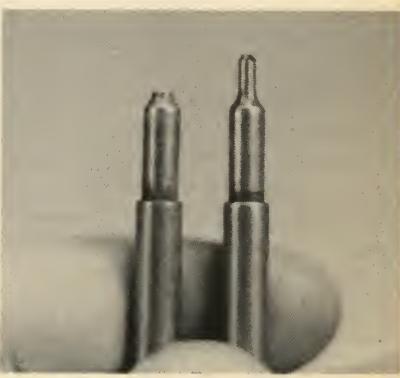
are cut diagonally, from the head forward, for clearance of the lever cam which moves the breech block. This leaves a wider section at the head, and a narrowed point partway up the body of the firing pin—the point at which they are prone to snap. The part is still available from Marlin for about \$3, and wise owners of these rifles will keep a couple of spare firing pins on hand. Here, again, installation is not for the amateur, as it involves dealing with several small pinned parts.

Broken firing pin points are not a chronic ailment with the Model 57M, but when it happens, and no replacement is available, the pin can be repointed by a gunsmith.

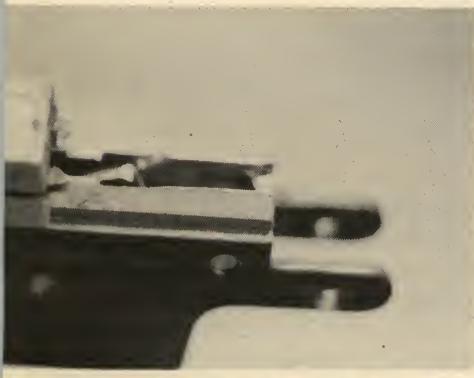
The cartridge guide, or feed throat, of the Model 57M is a two-part unit, but its design and alloy construction make it very similar to the one used in the Marlin Model 49 and 99 rifles (q.v.), and it shares some of the same problems. The ejector, for example, is a raised lug at top left rear, and it is susceptible to both wear and breakage. If this is the only problem with the feed throat, there is, as the saying goes, good news and bad news. The two-piece construction allows replacement of only the left part, the one with the ejector, and Marlin still has this part. The installation, however, is best done by a gunsmith, as it requires removal of the sideplate mentioned above.

The cartridge guide (feed throat) of the Model 57M is very similar to the one used in the Marlin 49 and 99 rifles and shares some of the same problems.

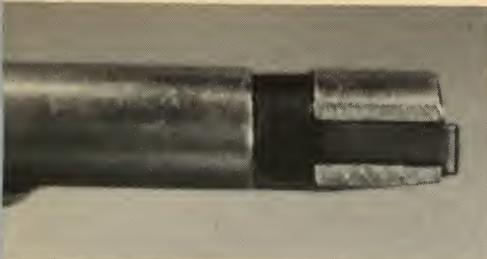
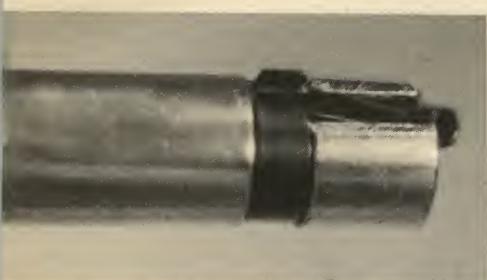
The extractor is a spring-clip type, similar to those used in several other Marlin guns, and these are susceptible to occasional breakage. When it happens, though, it's not a serious prob-

The extractor (top and bottom) is a spring-clip type, and breaks somewhat more often than those of machined steel design. The part is very inexpensive, and easily installed.

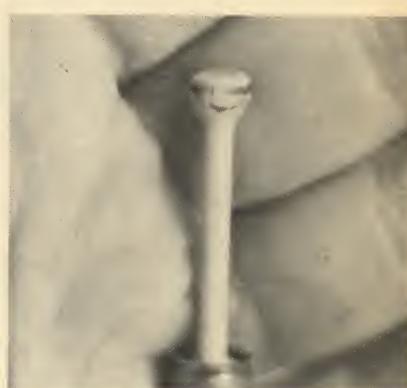
Like those on several other Marlin .22 rifles, the magazine follower is made of plastic and does not often break in normal operation. However, when the magazine tube is removed from the gun, careless handling can break or deform the follower. The rear sight is of similar design to the one used on the Marlin 336 rifle, with a folding leaf retained by lateral spring tension of the rear arms of the sight base. The sight elevator in its slot at the center tends to keep these arms from being compressed, but care should be taken in heavy brush, as a sharp blow can cause the leaf and elevator to depart, leaving the base on the barrel.

While it's not subject to breakage during normal operation, the plastic magazine follower can be damaged when it's out of the gun.

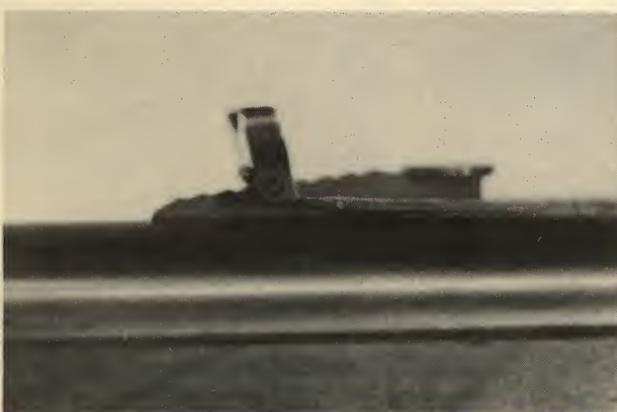
On late Marlin guns of this series, the rear sight is retained on its spring-leaf base by side projections on the leaf which fit into holes in the lower wings of the sight. Quite often, in brush country use, a swat from a small tree branch can spring one of the base lugs out of its hole in the sight, and the sight will depart, never to be seen again, along with its elevator. If your original sight is this type, it might be well to tuck a spare sight piece and elevator into your hunting pack, and take care to keep brush away from the top of the barrel. This, incidentally, is the only real criticism I can make on this good Marlin design, and it is easily corrected. If you ever lose the sight piece, just replace the whole thing with a Lyman # 16, and you won't be bothered by this again.

The rear sight is retained on its spring leaf by lateral projections that fit into holes in the base of the sight. A sharp blow can flex the spring, releasing the sight.

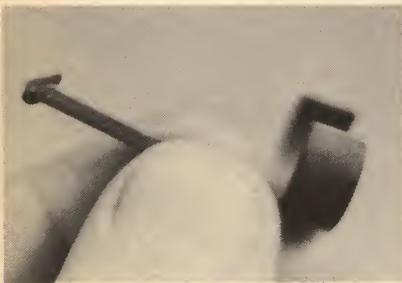
The extractor is the usual Marlin clip-on type, made of formed sheet steel. The beak occasionally breaks, but replacements are inexpensive.

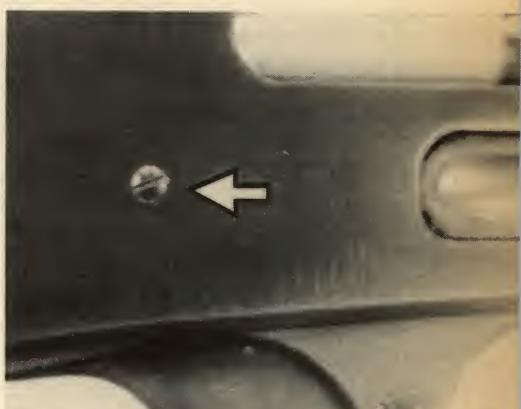
The arrow points to the mounting stud of the ejector, held in place inside the receiver by its track in the bolt. The ejector is powered by a blade spring, but breakage is not common.

Here, the arrow indicates the loading gate screw, which should be checked occasionally for tightness. It threads directly into the spring-tempered tail of the loading gate.

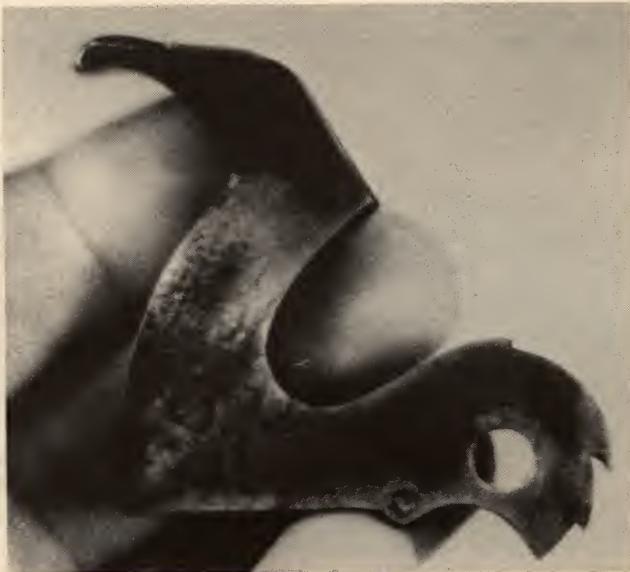
The hammer is a massive piece of nicely machined solid steel. The sear steps, seen at lower right, are susceptible to wear and breakage, especially the safety step. Repair is not difficult.

nicely-machined solid steel and gives no trouble other than wear or breakage of the sear steps on its front face, after years of hard use. The safety step breaks most often, as it is a deeper cut, with an overhanging flange. The steps can often be recut, or, if necessary, built up with weld, recut, and rehardened.

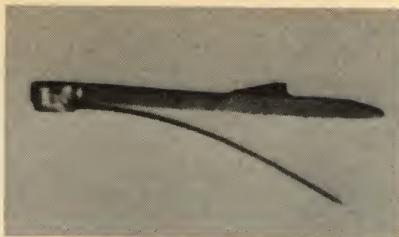
This is the ejector, which lies in a recess in the left inside wall of the receiver. It is powered by an attached blade-type spring, and these occasionally break. Fortunately, replacement is no great problem.

The ejector resembles the ones used in most Marlin guns, including some that are still in production. It is cammed into its recess in the left wall of the receiver by the closing bolt, and its small blade spring receives repeated compression. This is a simple, curved flat spring, and making a replacement is no problem for any gunsmith, or even the knowledgeable amateur. Breakage of the ejector itself is quite rare.

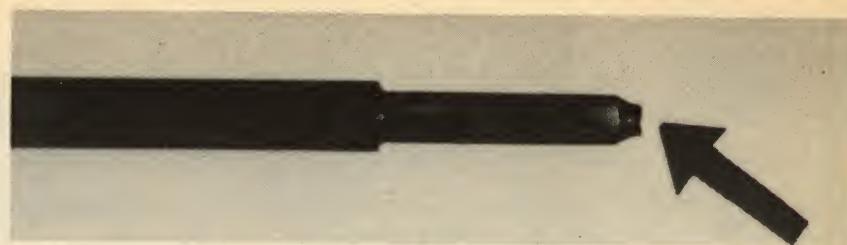
The tip of the firing pin breaks with some frequency, mostly because of age and crystallization. Considering

When a firing pin tip breaks, it's a serious problem, since the rear portion of the pin is rather intricately shaped, and no parts are available.

the parts situation, this can be a serious problem for the non-gunsmith. Fortunately, these can be repaired. A hole is drilled in the end of the pin, and a new tip fitted to it, held in place either by silver solder or by cross-pinning. Making an entire new firing pin is impractical, as the rear portion of the pin is keyed into the bolt locking system, and its shape is rather intricate.

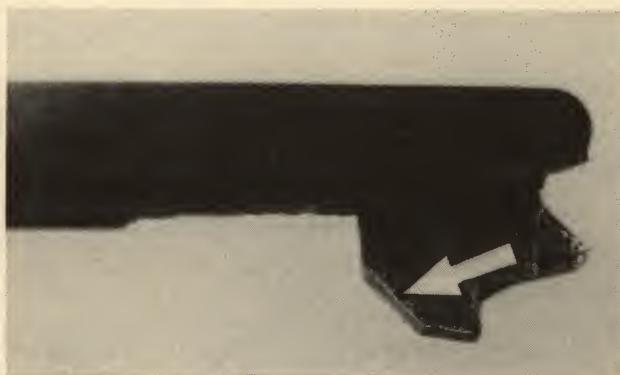
Extreme wear on the locking surface of the lower projection of the breech block (arrow) can prevent a firm lock-up of the 39's action.

slack. The trouble with this is that these narrow peened-up edges will quickly wear off, leaving the situation where it was before, if not worse. The proper way is to add steel weld to the top of the lever arm, recut it to fit, and reharden the end.

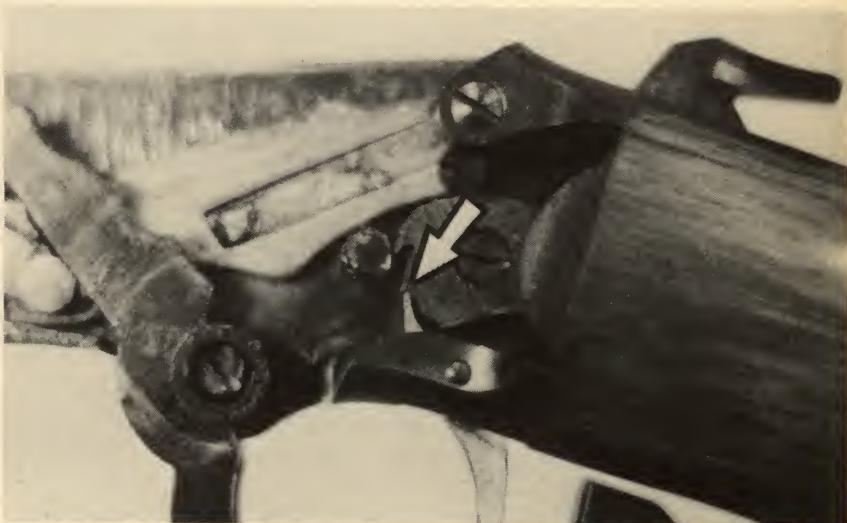
Simply an upper projection of the trigger, the sear makes direct contact with the safety and full-cock steps on the hammer. This slim top part of the trigger occasionally snaps off, either from age, brittleness or from someone letting the hammer slip too many times when cocking. When this breakage occurs, the blunt end of the broken sear will no longer function with the safety step; and, depending on the nature of the break, it may fail to keep the hammer at full-cock. It is possible to build up and recut a broken sear, but it makes much more sense to simply replace the trigger. With the new part, some fitting may be necessary, and it's best for this to be done by a gunsmith.

This view provides us with a look at the 39's sear engagement (arrow). The "sear" itself is an upper projection of the trigger which fits into one of two recesses in the hammer. The upper "notch" (or recess) is the half-cock position—it serves as the safety.

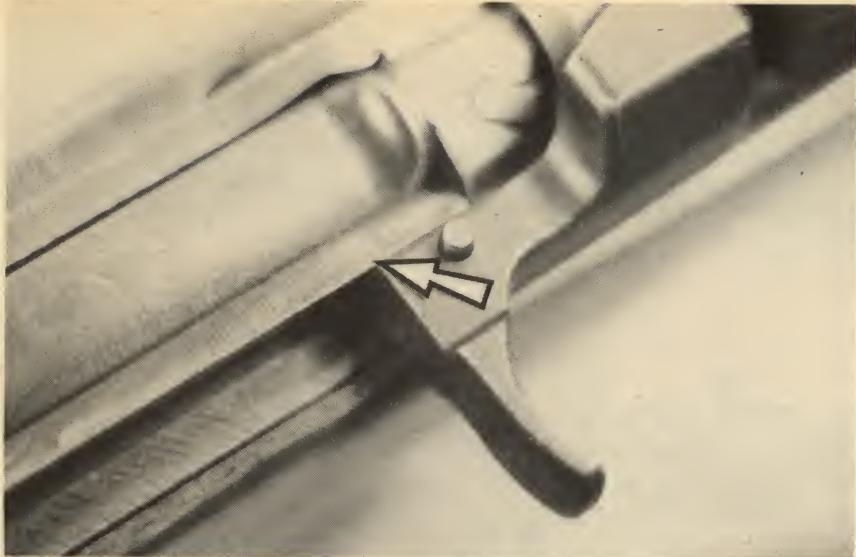
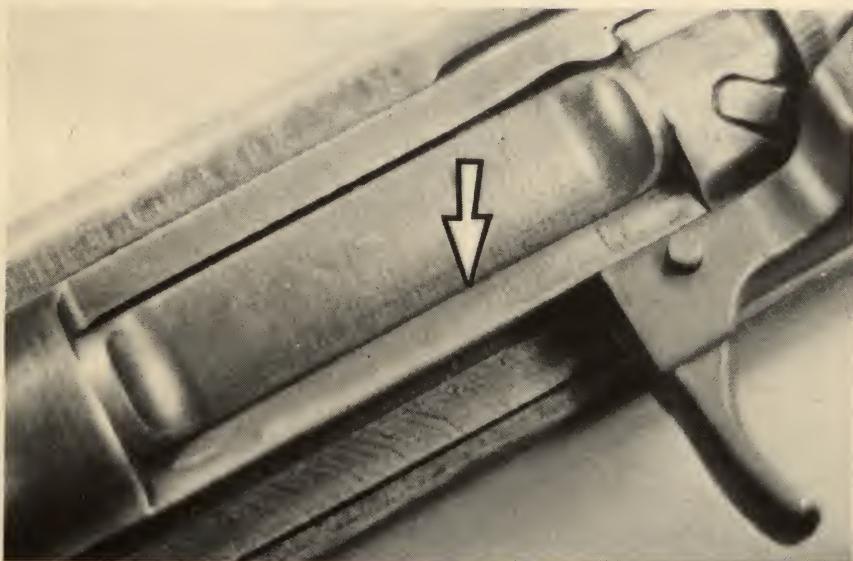
The right receiver rail, which contains the track for the action slide lug (top), is also internally curved to accommodate the bolt (bottom)—as a result, this section of the receiver is understandably quite thin and cracking in this area has been observed.

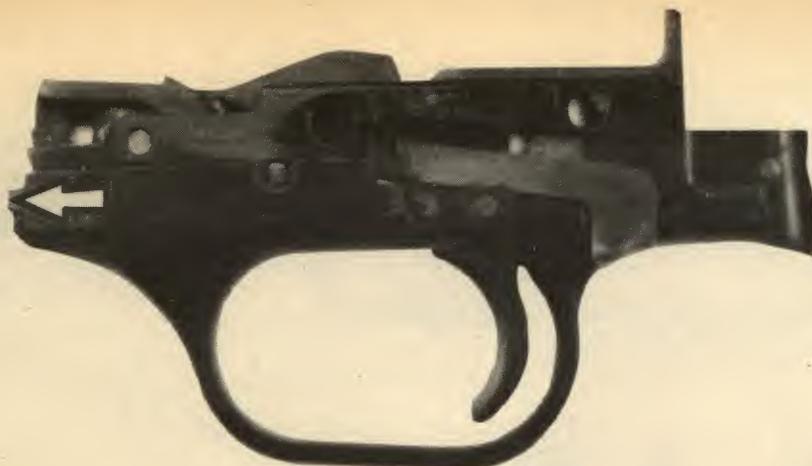
On later Mossberg 500s, the trigger housing is made of plastic—the forward retaining lugs (arrow) occasionally shear off.

rear by a large cross-pin. At the front, a small lug on each side mates with a recess inside the receiver. After long use, these have been known to shear off. To avoid replacing the entire housing, it is possible to drill an angled hole at each forward corner and install steel pins to replace the broken retaining lugs. In time, though, the pins may loosen in the plastic. When this occurs, they can be fixed in place with epoxy glue. In the mechanism of the housing, there are seldom any problems. All of the parts are well-designed, and there are no inherent weak points that might cause trouble.

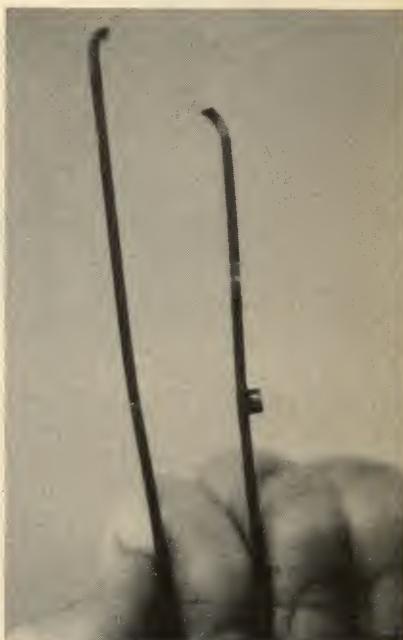
In this "edge-view" of the right and left shell stops, you can see that they are not flat, but slightly angled. The degree of angle is critical to feeding.

are not flat, but are slightly angled. The precise degree of angle is critical to the feeding, and any amateur attempt at reshaping them is likely to cause trouble. When one or both of the stops becomes worn, it is possible to restore them to the proper reach, but this is a job for a gunsmith. Here again, new ones are readily obtainable, and inexpensive, so a defective stop could simply be replaced. It's possible, though, that a new replacement could require slight adjustment to function properly.

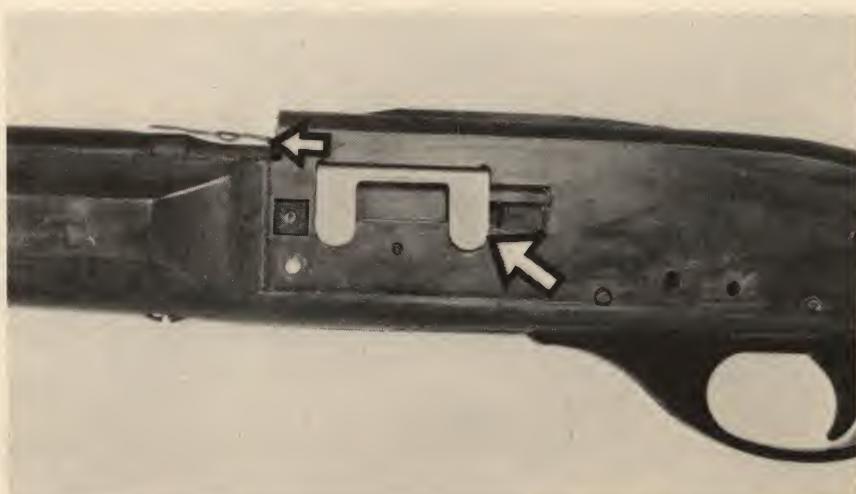
When reassembling, the cartridge guide (small arrow, upper left) must be in the position shown. The semi-horseshoe shaped ejector (large arrow) is retained only by the receiver cover—it can easily fall out when that cover is removed.

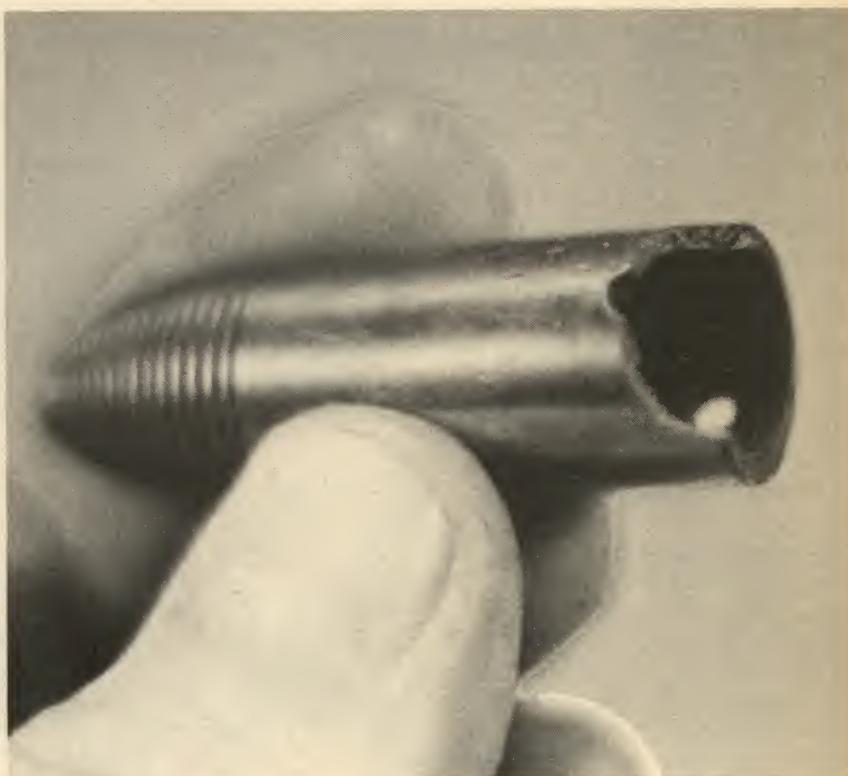
The bolt endpiece of the Remington 512 is hard—so hard that it's brittle. This bolt endpiece was not broken in normal use—it shattered when someone attempted to drive out the cross-pin with a tapered drift.

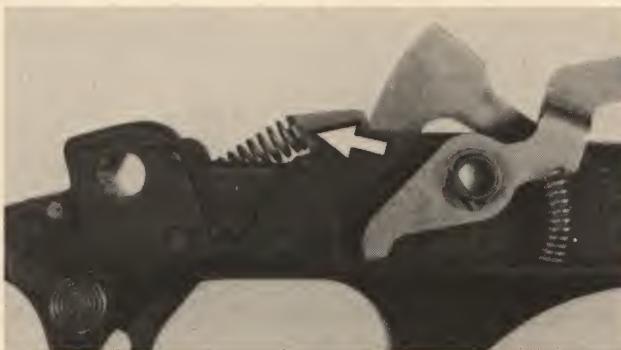
In the Model 552, one coil spring powers both the sear and the trigger (arrow). The spring to the right powers the cartridge lifter—the degree of tension of both of these springs is critical to proper functioning.

A single coil spring, a fairly heavy one, powers both the sear and the trigger and is mounted between studs on the two parts with no other retention. It is easily detached when the trigger group is out of the receiver, and if it should be lost, keep in mind that the tension strength of this spring is critical, both for proper operation and to keep it in place. If a non-original replacement is installed, it must have the same weight as the original. Replacements are, of course, readily available, and this applies to all of the parts. In regard to tension, the cartridge lifter spring is in this same category for the same reasons.

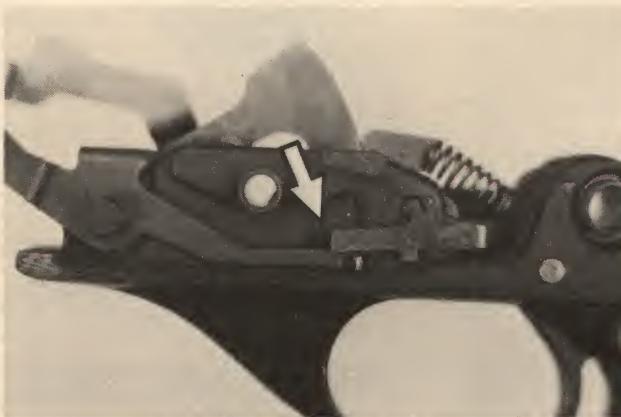
The mechanism of the trigger group is of good design, and breakage is quite rare. On the left side of the housing the long rear arm of the disconnector meets the left arm of the sear connector, and in careless reassembly it is possible to reverse the engagement.

Arrow indicates the proper engagement of the rear arm of the disconnector with the left arm of the sear connector. CAUTION: If careless reassembly takes place, reversal of the engagement is possible.

As the photo shows, the proper position is for the disconnector arm to lie below the sear connector.
